TÜV Rheinland Energie und Umwelt GmbH
51101 Köln

Declaration
- 21227704 – Climate tests on cabinet technoPLUS

Product: Polymeric cabinet
Type: technoPLUS 172

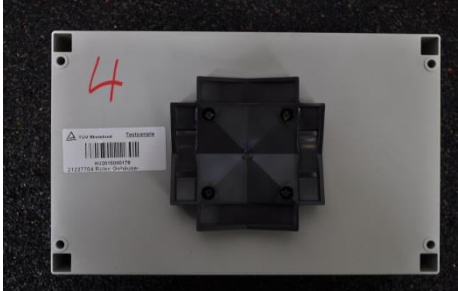
<p>Initial Inspection Back/ Box</p>

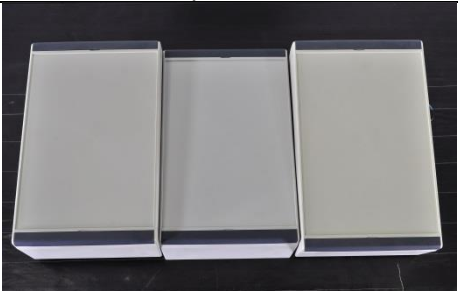
<p>Visual Inspection after UV</p>

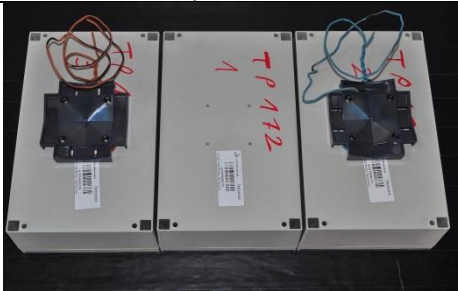
<p>Visual Inspection after UV</p>

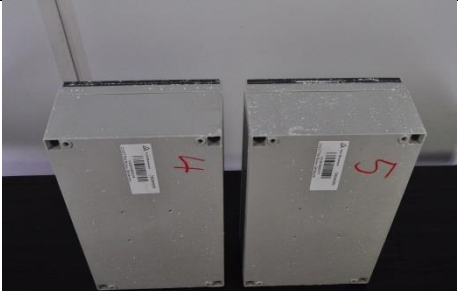
<p>Visual Inspection after salt mist</p>

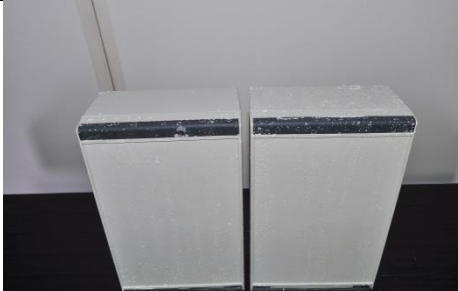
<p>Visual Inspection after salt mist</p>

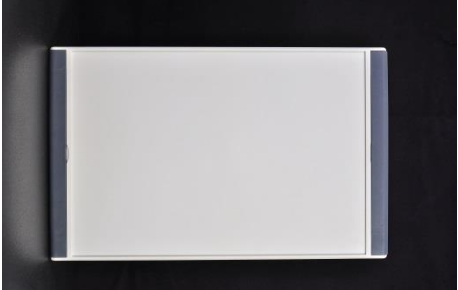
<p>Visual Inspection after DH 65°C</p>

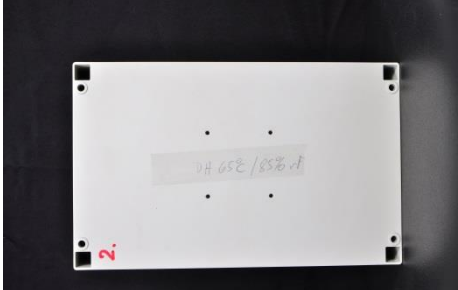
<p>Visual Inspection after DH 65°C</p>
